FOR JULY 1, 1993 THROUGH OCTOBER 1, 1993

HISTORICAL RELEASE REPORT (HRR)

**ENVIRONMENTAL RESTORATION
FACILITIES OPERATIONS MANAGEMENT**

Historical Release Report (HRR)
Quarterly Report Submittal
July 1, 1993 - October 1, 1993

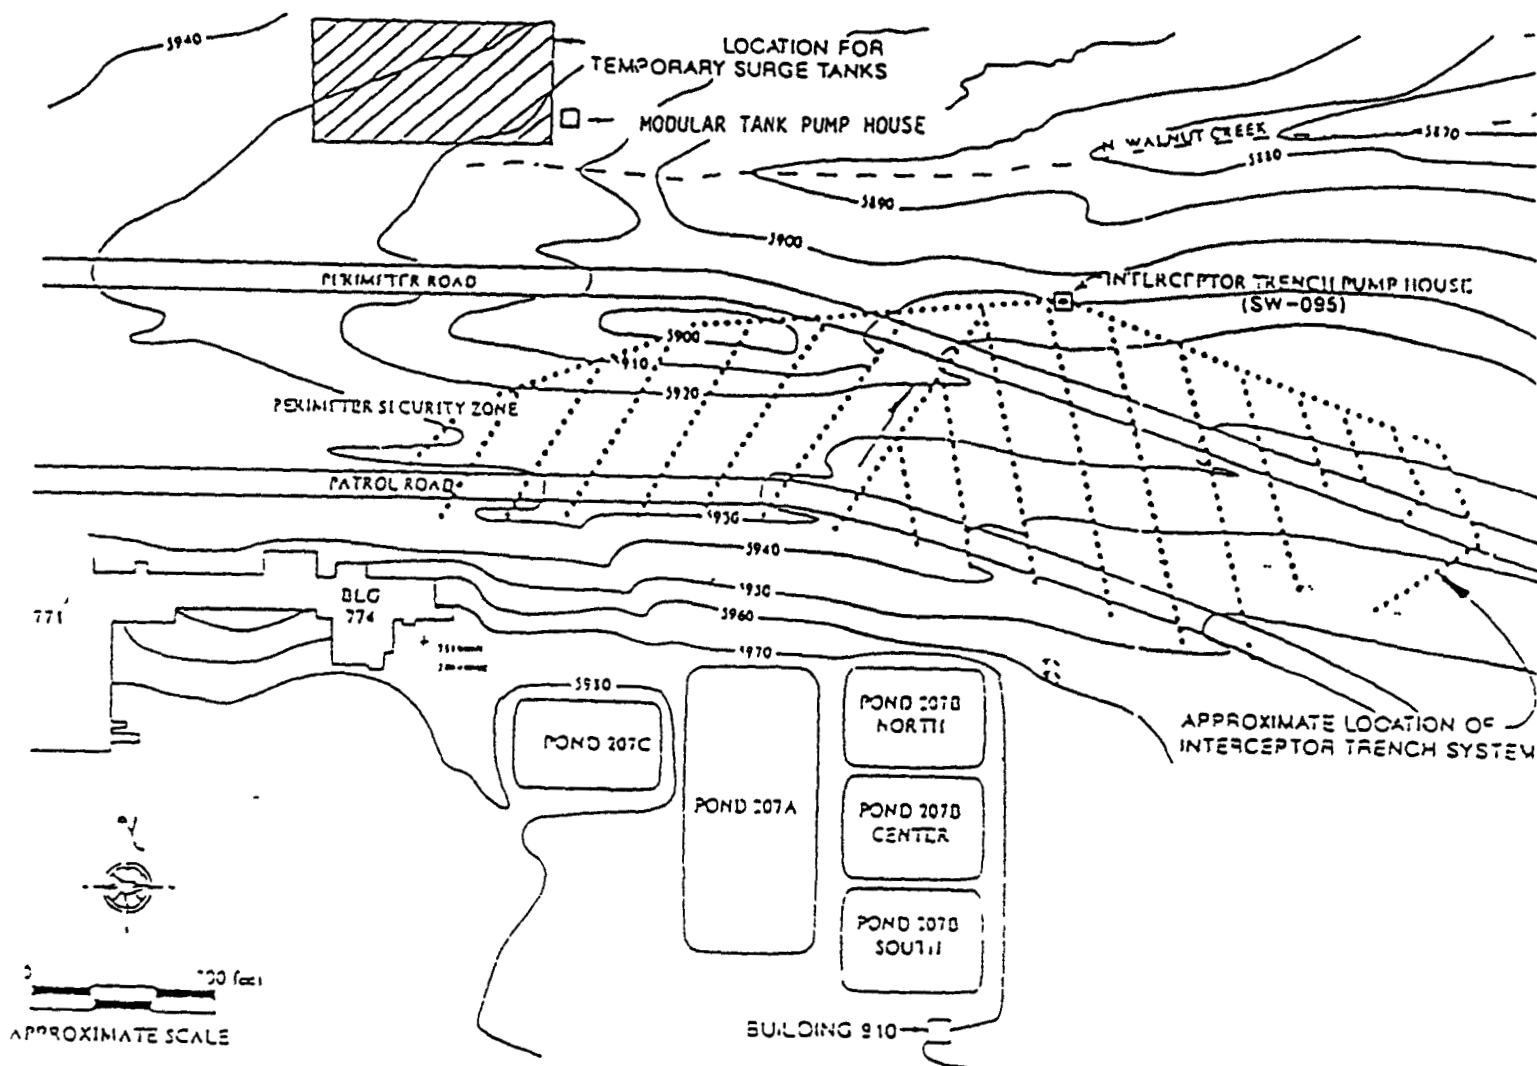
FIGURE 1

The system includes a) Interceptor Trench System (ITS), b) three (3) Modular Storage Tanks, c) Building 910 Treatment System, and all related ancillary equipment. Figure 1 is a system layout and Figure 2 is a schematic of the transfer systems. The following is a description of the system components.

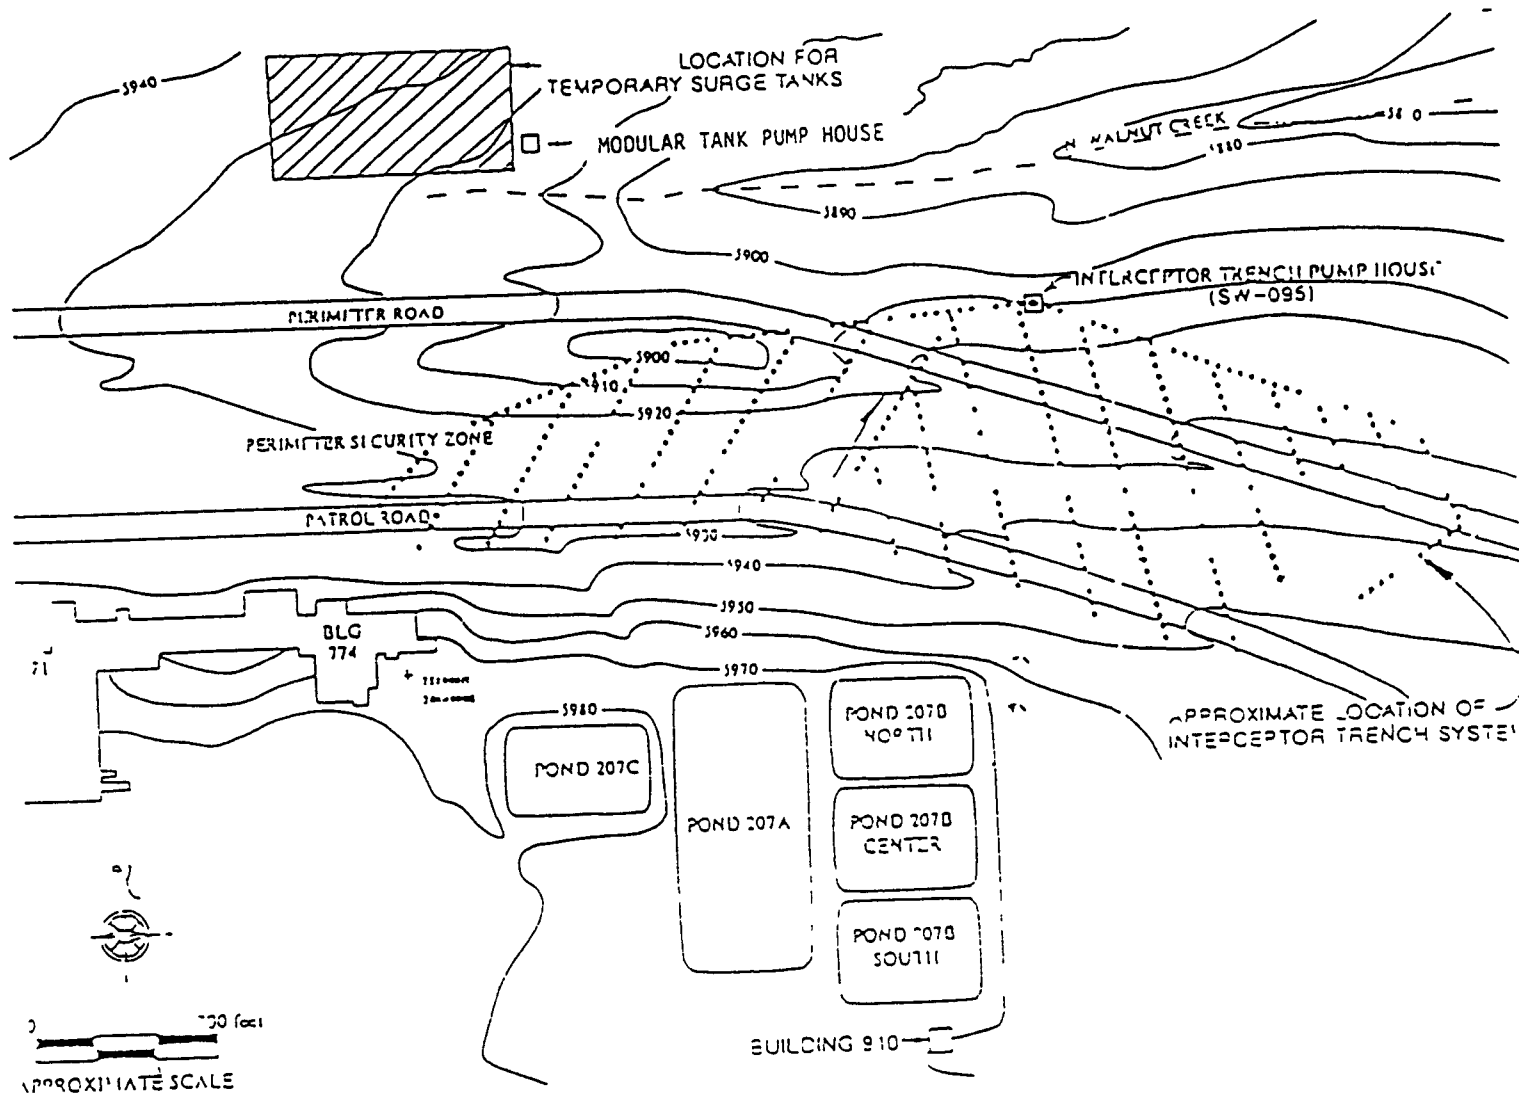
FIGURE 1

The system includes a) Interceptor Trench System (ITS), b) three (3) Modular Storage Tanks, c) Building 910 Treatment System, and all related ancillary equipment. Figure 1 is a system layout and Figure 2 is a schematic of the transfer systems. The following is a description of the system components:

- 2) The ITS sump is an underground, unlined, concrete vault that stores the surface and ground water (reference Figure 2 - item a2) The ITS sump is not secondarily contained.
- 3) A small building housing two pumps is located on top of the sump (reference Figure 2 - item a3) The sump pumps transfer the surface and ground water collected in the sump several hundred feet to the modular storage tanks. In accordance with 6 CCR 1007-3, the pumping operation is considered a waste generation point At this point, the generated waste (pumped surface/ ground water) is characterized as RCRA hazardous waste.

- 4) The RCRA hazardous waste (pumped surface/ ground water) is pumped from the ITS sump pump, through a 3-inch secondarily contained, buried pipe, several hundred feet to one of 3 modular storage tanks (reference Figure 2 - item a4)
